28 February 2023 V2

**HUNDLEBY PARISH COUNCIL,  
PARISH ROOMS,  
OLD SCHOOL HOUSE,  
CHURCH LANE,  
HUNDLEBY,  
LINCOLNSHIRE,  
PE23 5NB**

**FEASIBILITY REPORT**

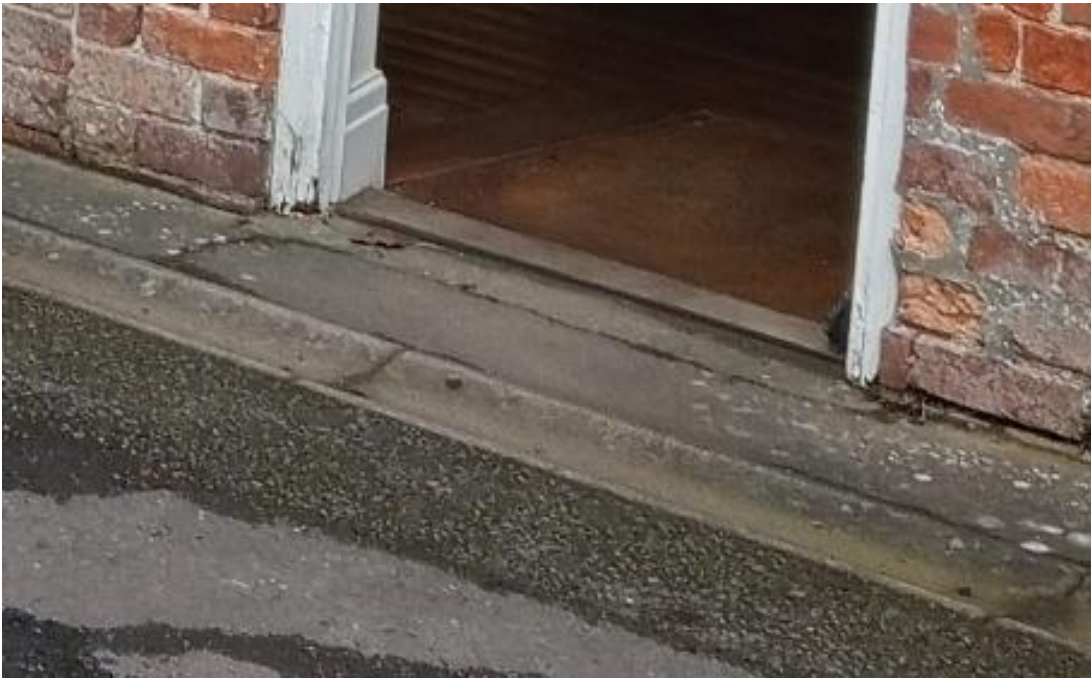
- Drainage channel across the front door.
- Narrow door widths.
- Threshold and narrow door forming fire exit – not level
- High counter.
- Disabled toilet is provided but access to it is restricted.

Uneven main entrance

The inaccessible fire exit and entrance is restrictive for wheelchair users and those with mobility issues, wider level access doors would be required.

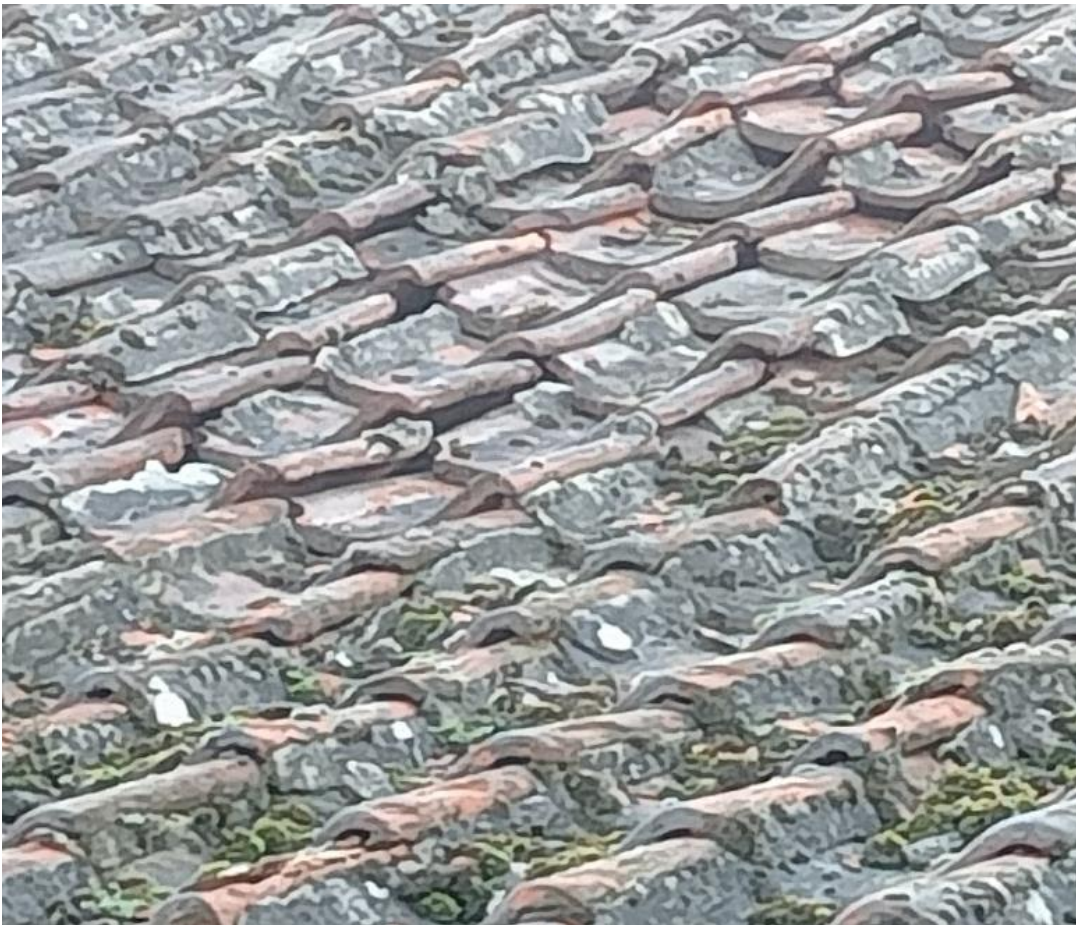
The roof is antique clay pantiles and flat felt roof, the condition is poor, the pantiles are original or reclaimed and they are cement pointed, the tiles and pointing is deteriorating and breaking up from age and frost attack, some tiles are mis-placed and leaking, manifesting in brown stains on the ceiling particularly over the kitchen.

Roof issues

Roof - needs stripping back to rafters and felting battens and retiling with new tiles, lead flashing and insulation to current standards. The flat roof needs recovering and insulation adding together with soffit fascias and gutters

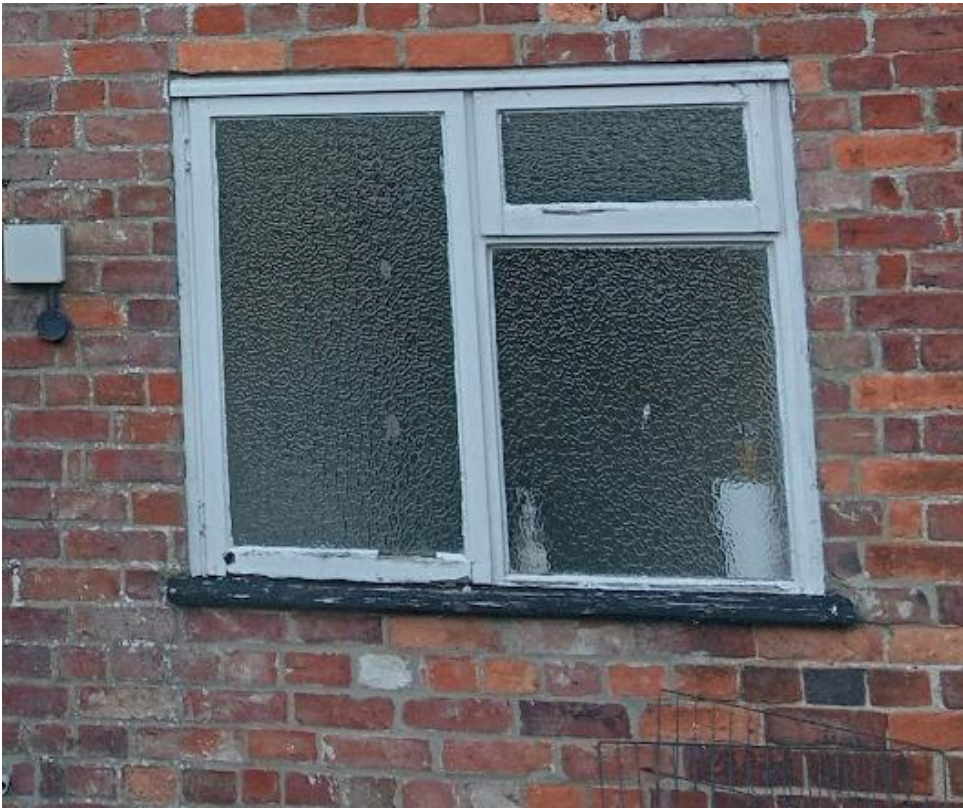
The windows to the front elevation are double glazed upvc. There are some timber windows to the rear that need replacing.

Deteriorating timber windows to rear

Window – most of the windows are double glazed upvc there are some timber windows to the rear which are ready for replacement.

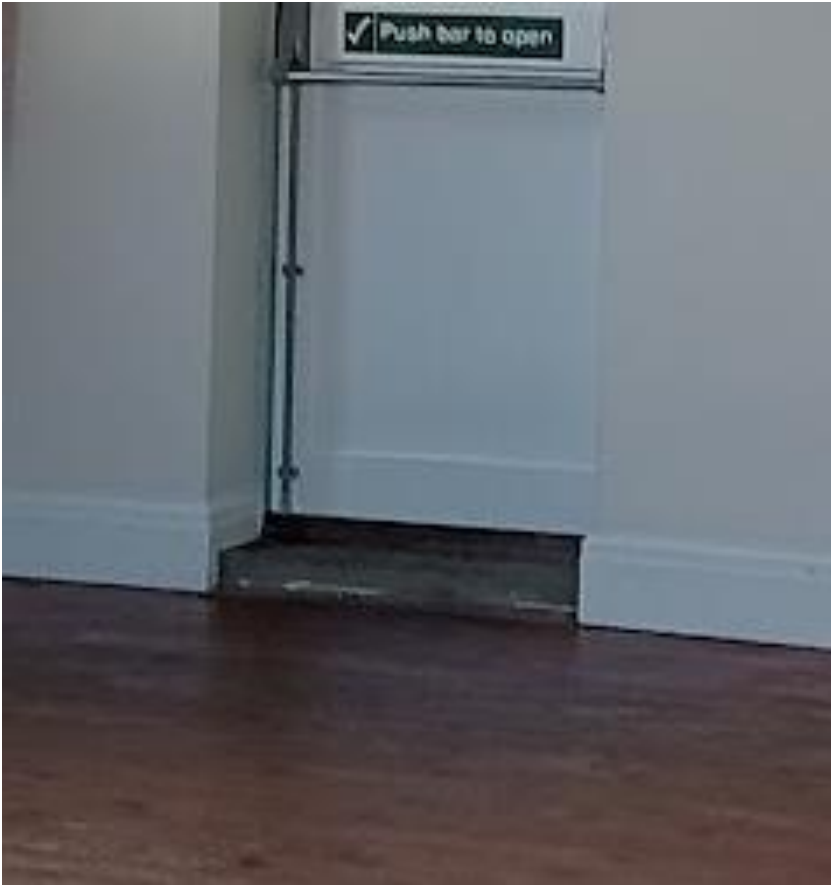
Inaccessible fire exit
